PHASE 1 IMMEDIATE ACTION REPORT

Jordan Lane, PE, SE
Structural Engineer
North Delta Engineering
1914 E. Matthews Ave.
Jonesboro, AR 72401
AR License No.: 12969

City of Jonesboro
300 Church Street
Jonesboro, AR 72401

Building Location: 100 W. Washington Ave., Jonesboro, AR

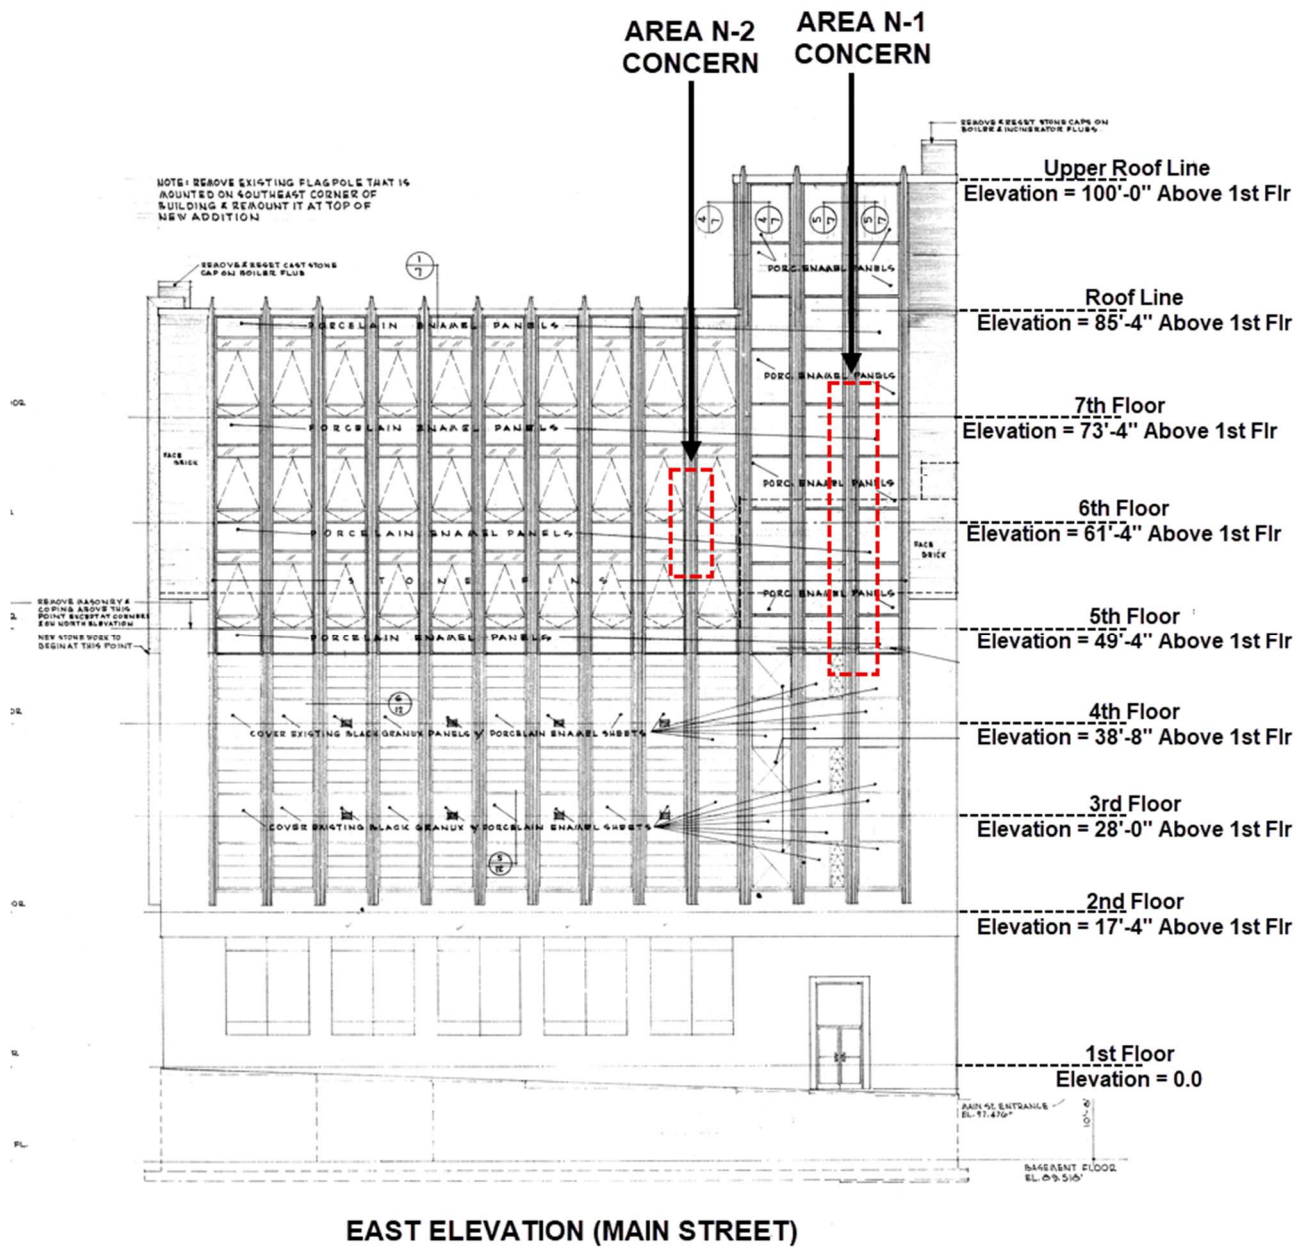
Figure 1: Elevation Showing Wall Areas That Have Lost Substantial Lateral Support

There are two areas where the exterior wall structure appears to have lost lateral support, and the wall structure has moved away from the building and is deflecting out to the east towards Main Street. See figure 1 and figure 2 below and photo 1 showing these areas. The wall structure area furthest north (between the stairwell and elevator structure) has moved the most and is the most concerning at this time. The area of concern for wall area N-1 is located between the 5th and 7th floor of the building between the stair structure and elevator structure. The area of concern for the wall area N-2 is more isolated and occurs above and below the 6th floor level.

Wall area N-1 is deflecting outward (towards the east) several inches and appears to be at risk of collapse. The lateral ties from the steel beams to the vertical precast elements at area N-1 have been compromised and appears to have lost support for at least a twenty foot vertical length near the 6th floor level. Area N-2 is also deflecting outward (towards the east) several inches but does not appear to be as concerning as wall area N-1 at this time.

After the scaffolding and wood protection wall is constructed, it is recommended to add lateral bracing to the vertical precast concrete elements at area N-1 and N-2. This should be done before any other work or demolition begins on the structure. The lateral bracing should be made to area N-1 near the 5th and 6th and 7th floor levels and can be extended into the building and anchored to the concrete floor slab or some other solid structure. The lateral brace can be in the form of steel angles to grab the vertical precast concrete elements and stabilize them and possibly even pull them back into the building slightly. A licensed contractor should be engaged to add the lateral bracing to areas N-1 and N-2 before any façade removal begins.

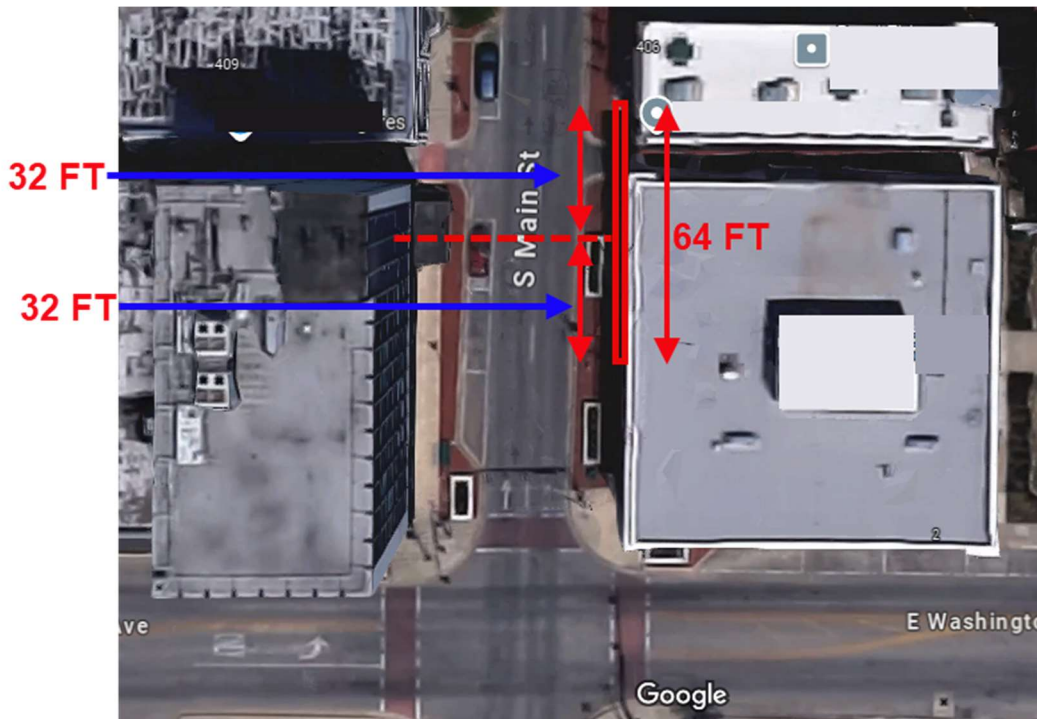
Figure 3: Aerial View Showing Recommended 2x6 Wood Protection Wall Location

Due to the risk of the vertical architectural precast concrete elements collapsing and falling away from the old Citizens Bank building, a protection wall is recommended to be constructed on the west side of the First Horizon building (located at 420 S Main Street) and on the west side of the Mutual of Omaha building (located at 408 S Main Street). The wall is recommended to be approximately 64 feet long and 16 feet tall to potentially protect any falling debris from entering or damaging the occupied these

two buildings. See figure 3 below for the recommended wall layout. The wall can be constructed approximately 32 feet north and 32 feet south of the unstable vertical precast at area N-1.

The wall is recommended to be constructed using steel scaffolding with 2x6 wood studs at 16-inches on center and attached to the scaffolding structure. The 2x6 wood stud wall should have 1 layer of 3/4-inch plywood nailed to each face of the wood studs. A lower diagonal 2x6 wood stud brace at 32-inches on center can be added at the bottom of the wall for additional lateral strength. A typical detail of the scaffolding and wood stud wall can be provided as needed.
