ADDITIONAL ENGINEERING EVALUATION ITEMS

Building Location: 100 W. Washington Ave., Jonesboro, AR

**Structural Assessment
100 W. Washington Avenue
Jonesboro, AR 72401**

PFI No. 26681.07

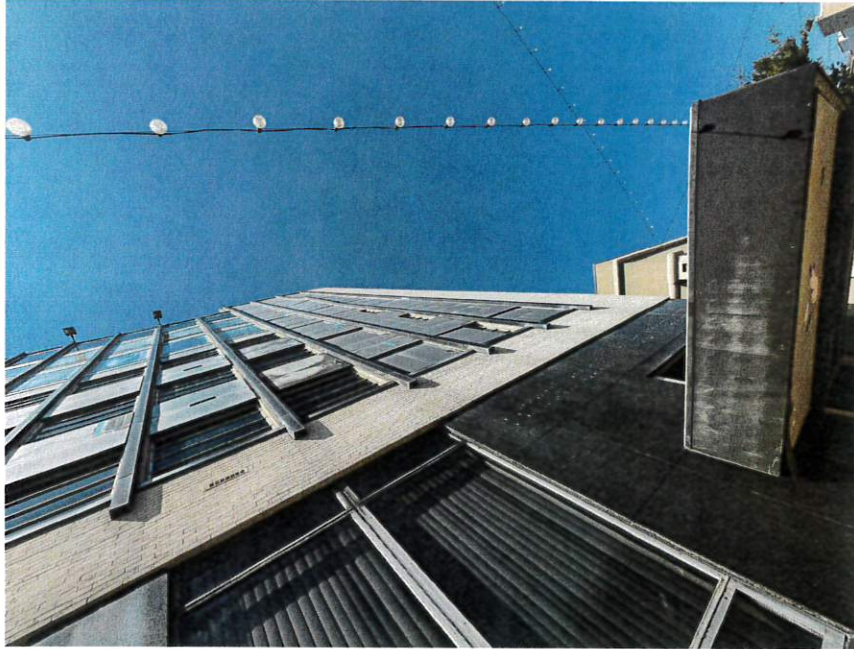
1. Building Face – East Side

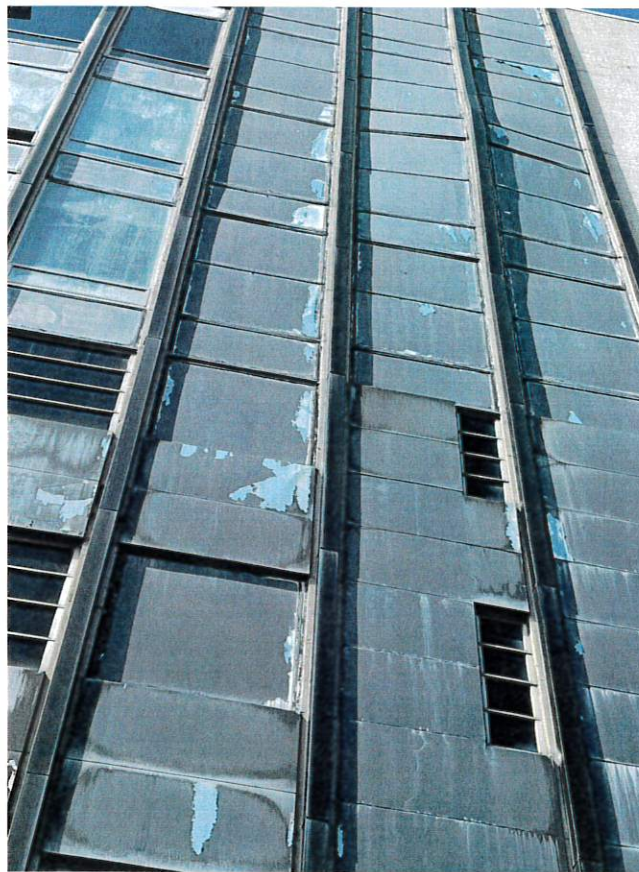
1. Trim between the windows appear to be bowing out (2).
2. Windows at sill appear to be separating from the floor; a gap is apparent (5, 6, 7, 10).
3. The attachment of the window sill to the floor edge appeared to be by means of concrete fasteners and the fasteners broke away from the floor (7)

1. The fact that few of the windows are bowing out may be an indication of loosening of the connection of the window frame to the building. This is evident at the sills of the windows that are visible.
2. It is not clear if and how the jambs of the windows are attached to the building structure.

2. Bow at Widows and Trim

1. Expose the frames of the windows and the porcelean panels by removing the trim at the outside of the building and the finish material at the inside in order to inspect the connections.
2. Expose the connection of the precast veneer to the building structure
3. Inpect the connections that are referenced above in order to verify adequacy and determine further action
4. Reinforce connections as required

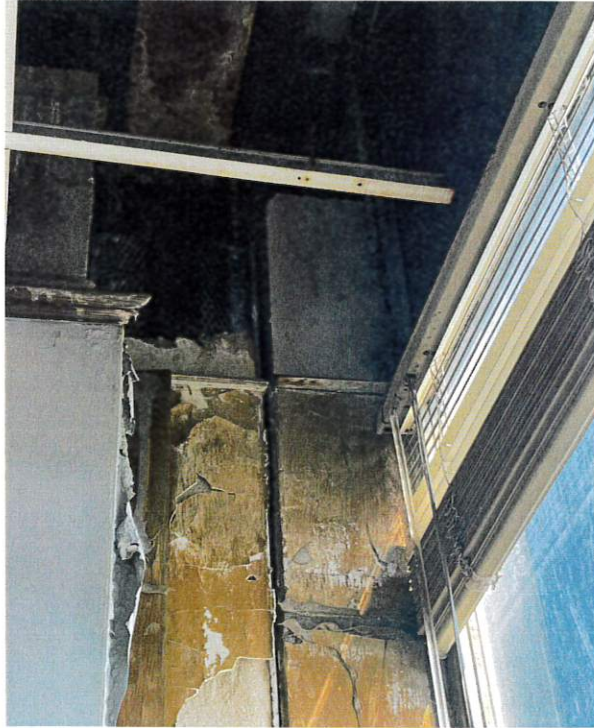
3. Precast at Column

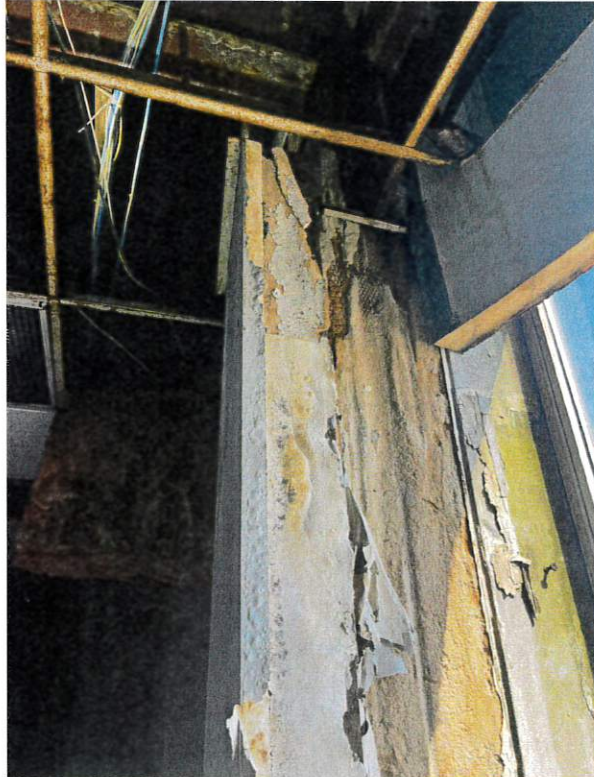
4. Floor Beam at Column

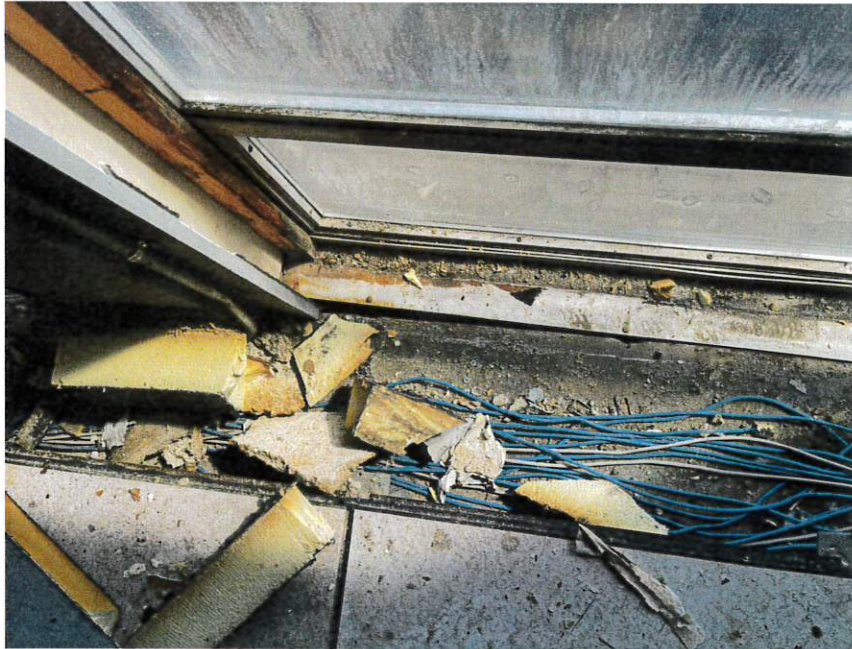
5. Gap at Window Sill

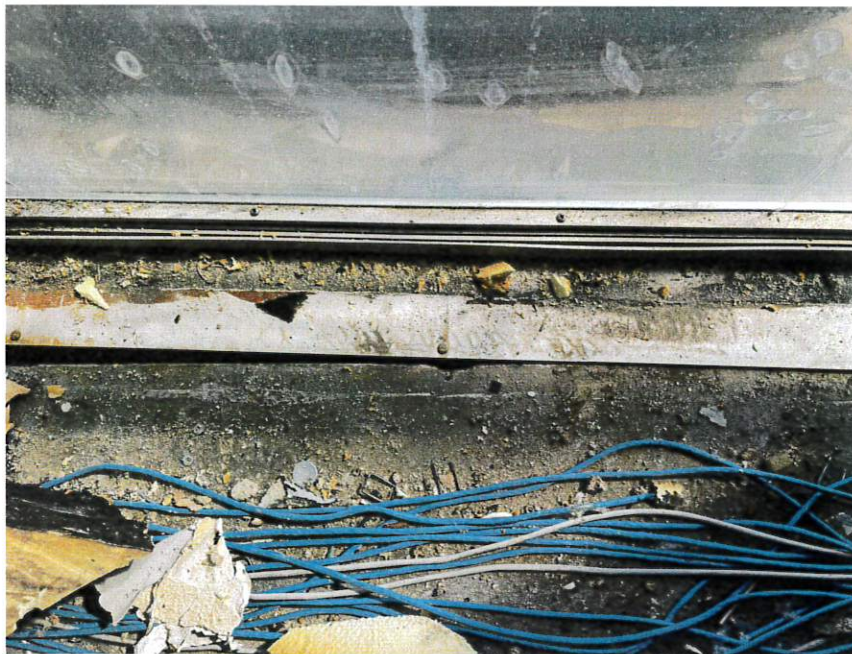
6. Gap at Window Sill

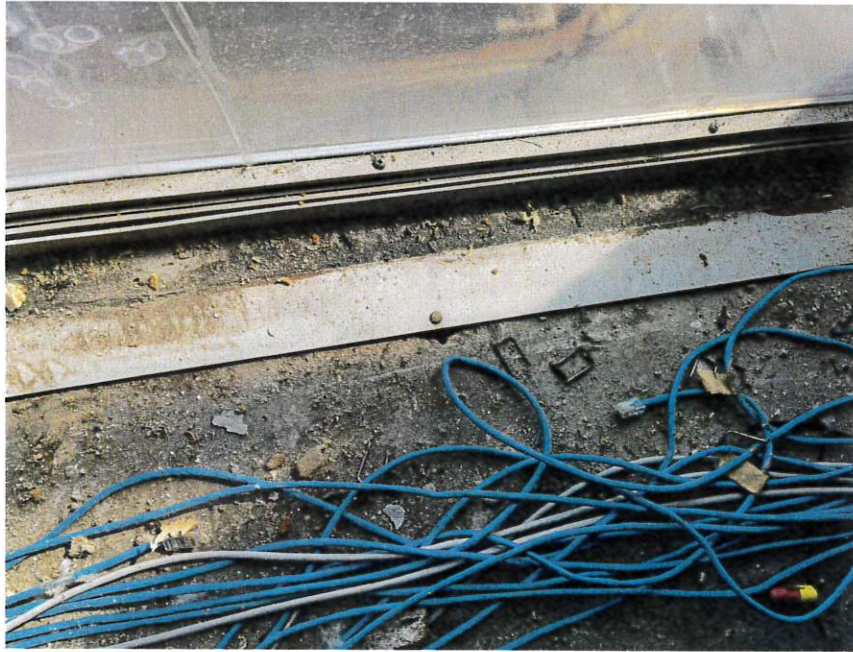
7. Fasteners are Missing at Window Sill

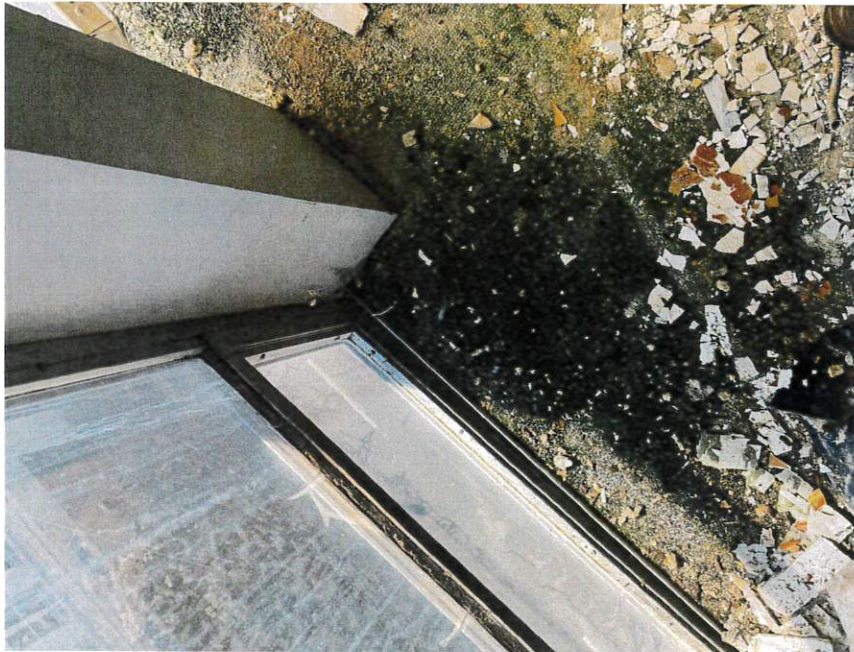
8. Window Jamb

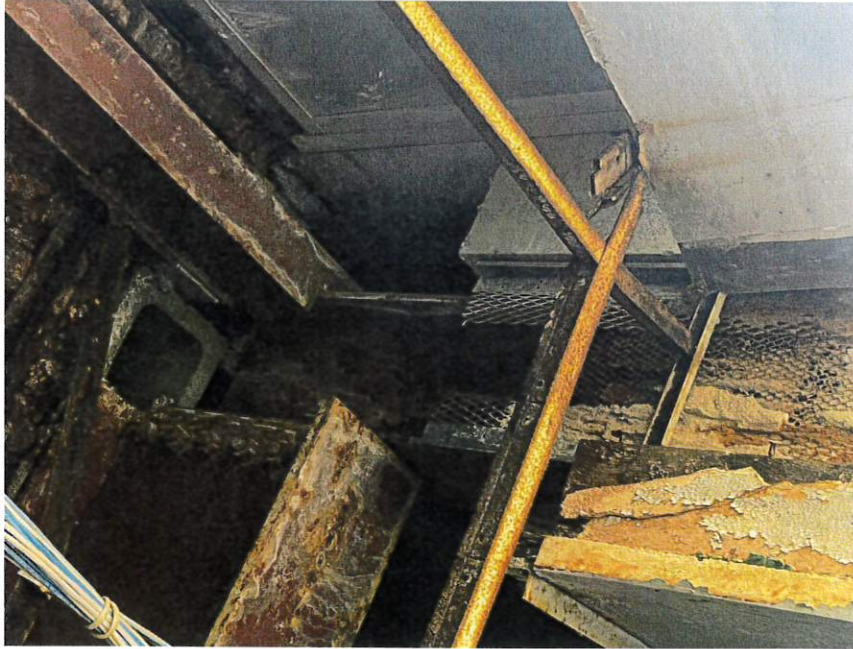
9. Floor Beam at Column Between Windows

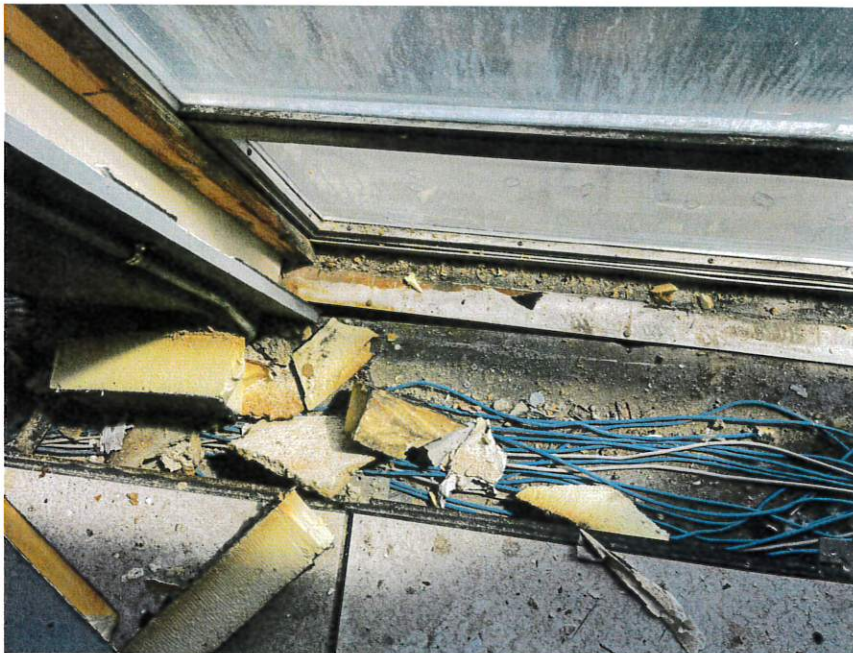
10. Gap at Window Sill
